# **ADVENTURE ISLAND**

# **LIGHTNING INCIDENT**

**AN IN-DEPTH REPORT ON THE DEADLY FAILURE OF AN  
EARLY STREAMER EMISSION LIGHTNING ROD**

**By**  
**Z. A. Hartono & I Robiah**  
**June 2012**  
**E-mail: [zahartono@iecc.org](mailto:zahartono@iecc.org)**

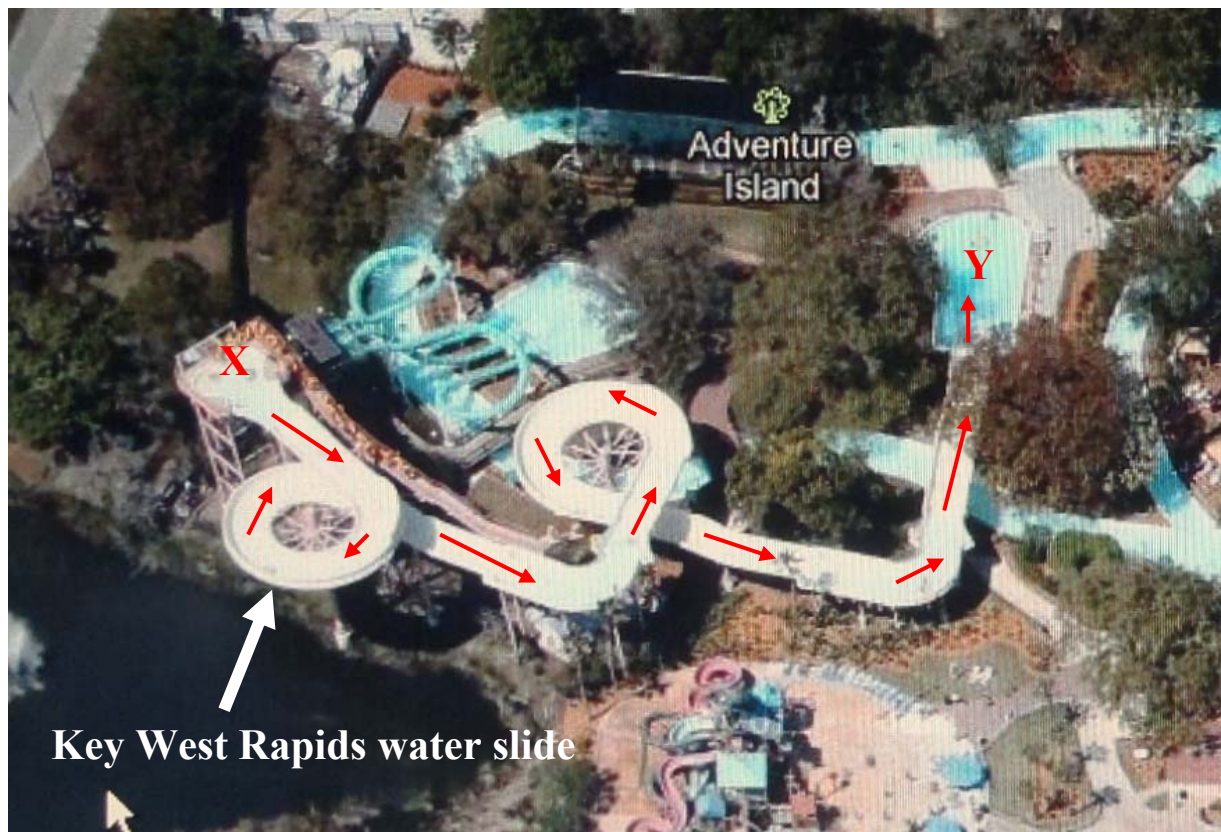
Fig. 1: The Key West Rapids water slide. (Source: Google Map/Satellite view)

According to the news report, the lifeguard supervisor was helping the guests off the KWR water slide when he was struck by lightning. However, the news report made no mention whether he was at the top (X) or bottom (Y) pool when the incident happened.

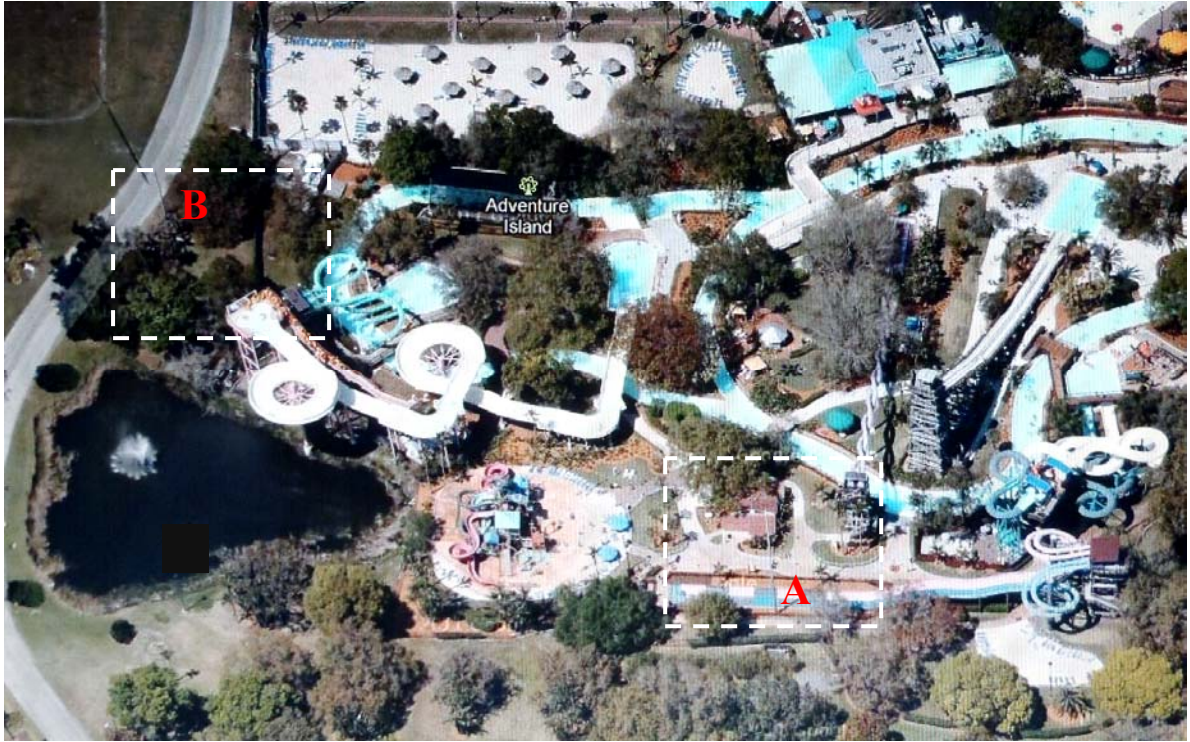
The water slide was found to be located in between two mast-mounted ESE lightning rods, A and B (Fig. 2). The lightning rod A (Fig. 3) is located besides the Riptide pool while the lightning rod B (Fig. 4) is located besides the parking lot access road.

Fig. 2: Location of the ESE lightning rods, A and B (Source: Google map)

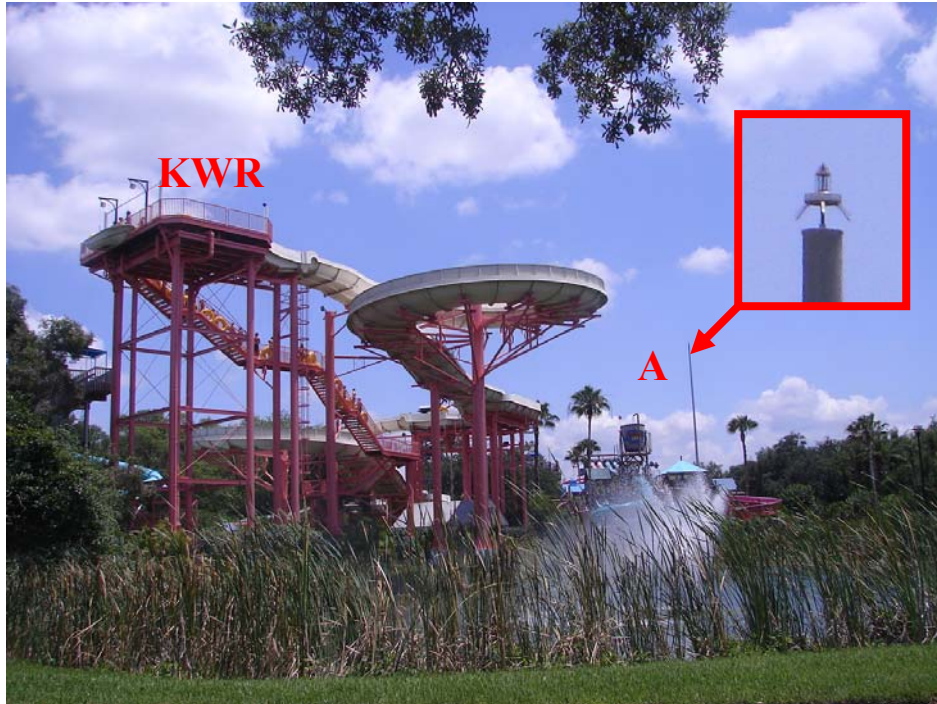
Photographs of the lightning rods taken from the access road are shown below (Figs. 5 and 6). The masts are estimated to be about 25m high each i.e. higher than the KWR top entry pool. Close-up shots of the lightning rods revealed that they are first-generation Prevelectron ESE lightning rods manufactured by Indelec of France.

Fig. 5: Position of lightning rod A in relation to the KWR water slide.

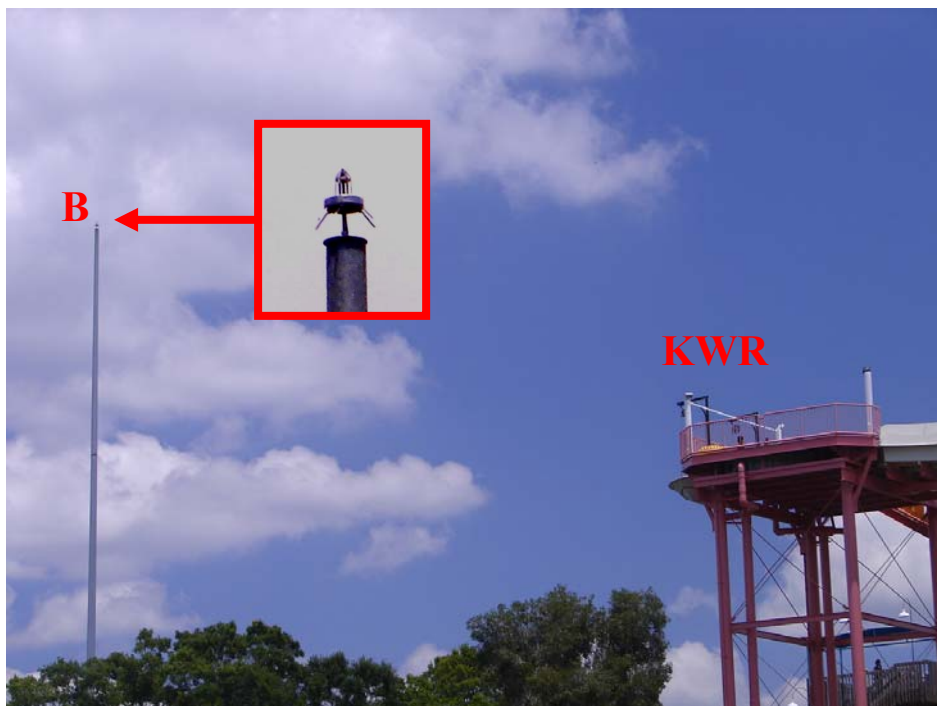
Fig. 6: Position of lightning rod B in relation to the KWR water slide.

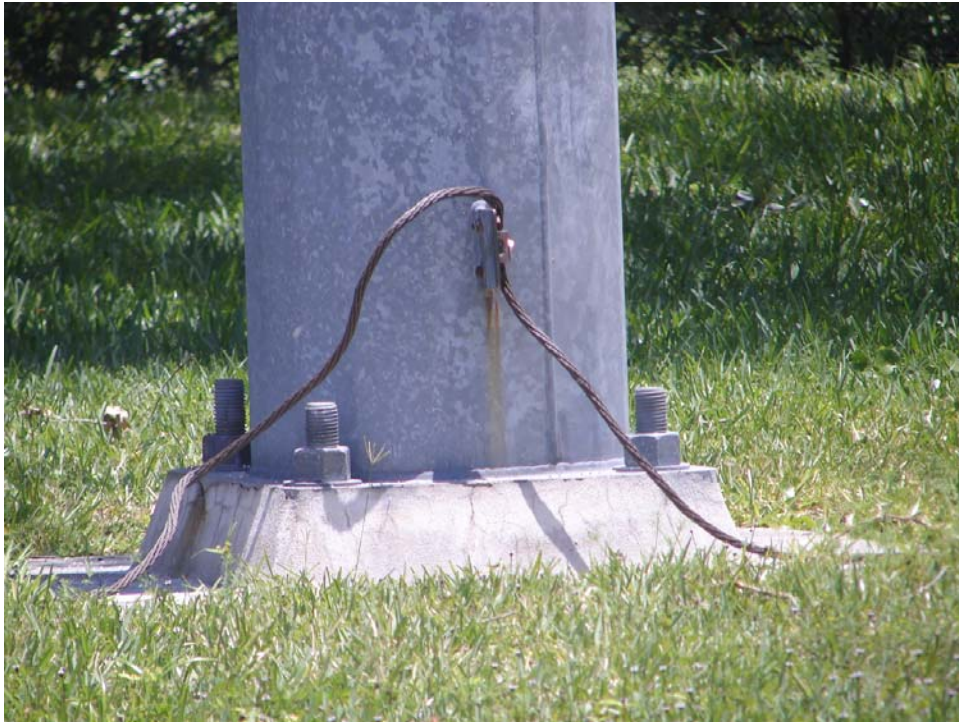
An inspection of the masts shows that the Prevectron lightning rods had been bonded to the masts and grounded according to the French ESE standard (Figs. 7 and 8).

Fig. 7: The base of the ESE lightning rod mast at B showing a grounding cable leading towards two grounding points..

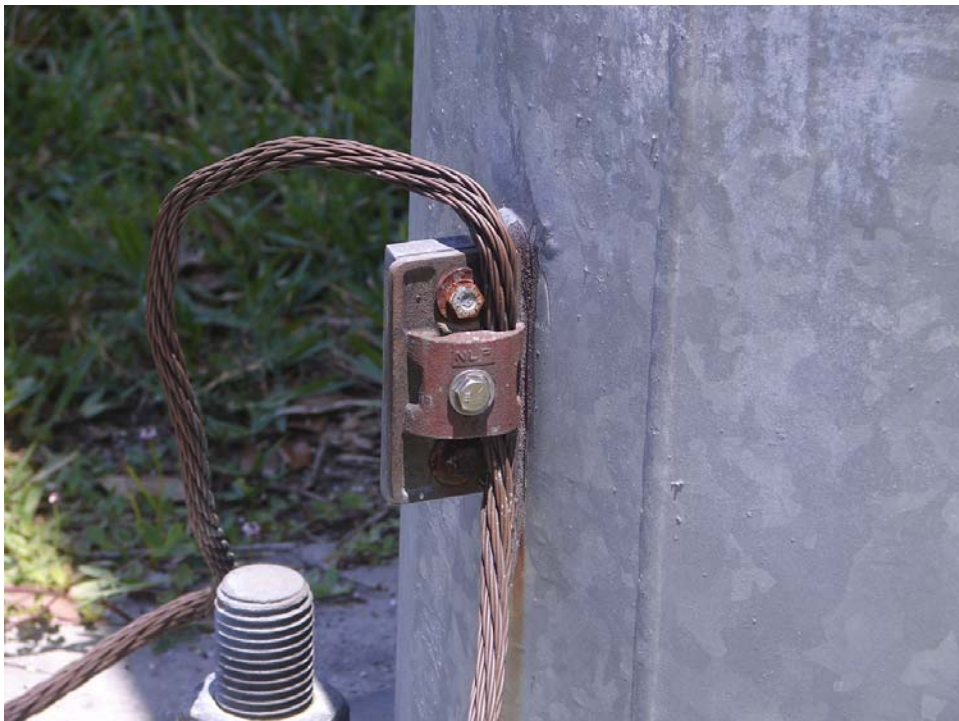
Fig. 8: A close-up shot of the bonding terminal on the mast..

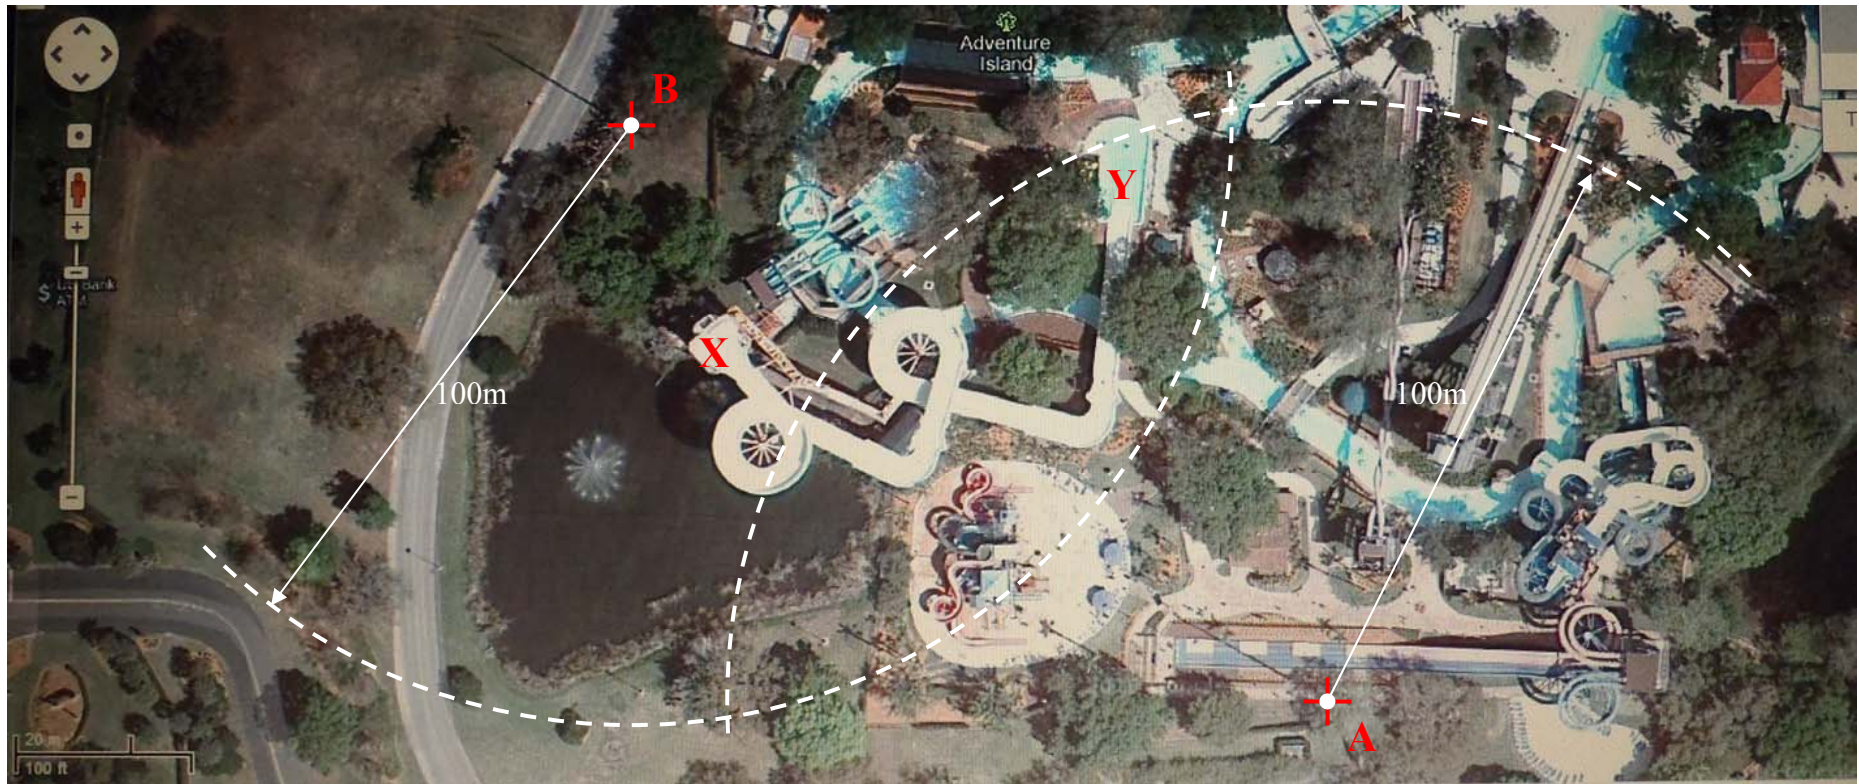
Using the distance scale provided by Google Map, it was found that both the pools X and Y were located within the claimed ESE protection zones (Fig. 12). The upper entry pool X was located within 50 m of the Prevectron lightning rod at location B while the lower entry pool Y was located within 100 m of both Prevectron lightning rods at locations A and B.

Since the victim was reportedly struck by lightning while he was on duty on one of the two entry pools, this incident provides firm evidence that the actual ESE protection zone is very much smaller than is claimed.

Fig. 12: The positions of the entry pool X and exit pool Y in relation to the Prevelectron lightning rods A and B. (Source: Google map)

In order to avoid further lightning casualties, it is highly recommended that theme parks be installed with NFPA780 compliant lightning protection systems and implement proven lightning safety rules.

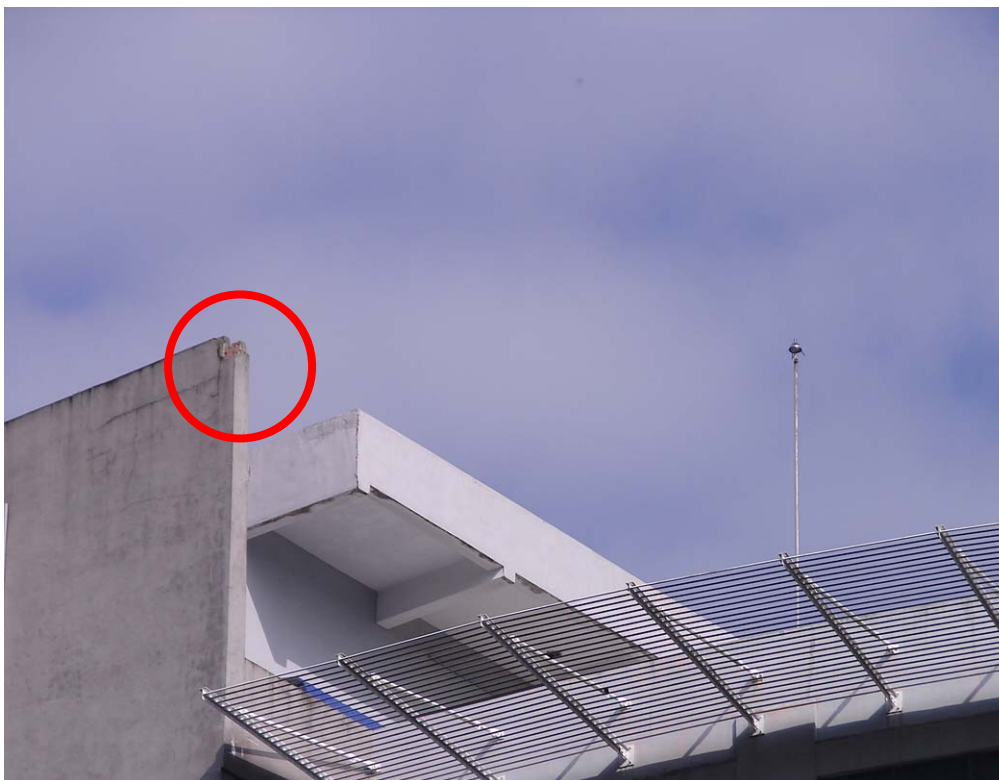
Examples of bypasses near second-generation Prevector lightning rods are shown below (Figs. 13 and 14). A Prevector lightning rod failure can also be inferred when another ESE lightning rod is installed next to it but with a higher rod tip location (Fig. 15). More cases like this can be found in our paper “ESE: The device for a modern answer to lightning protection?”

Fig. 13: The lightning damaged TNB building in Johor Baru, Malaysia.

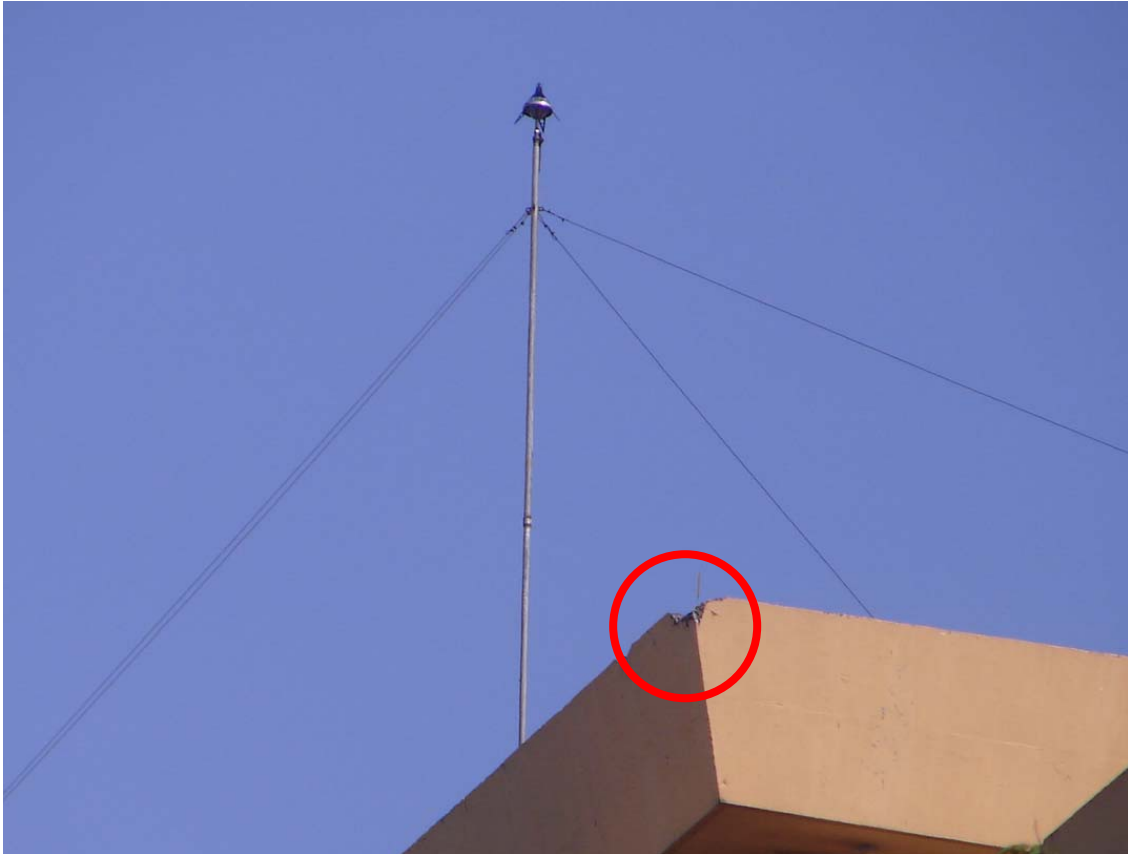
Fig. 14: The lightning damaged Sri Kota apartment in Kuala Lumpur, Malaysia.

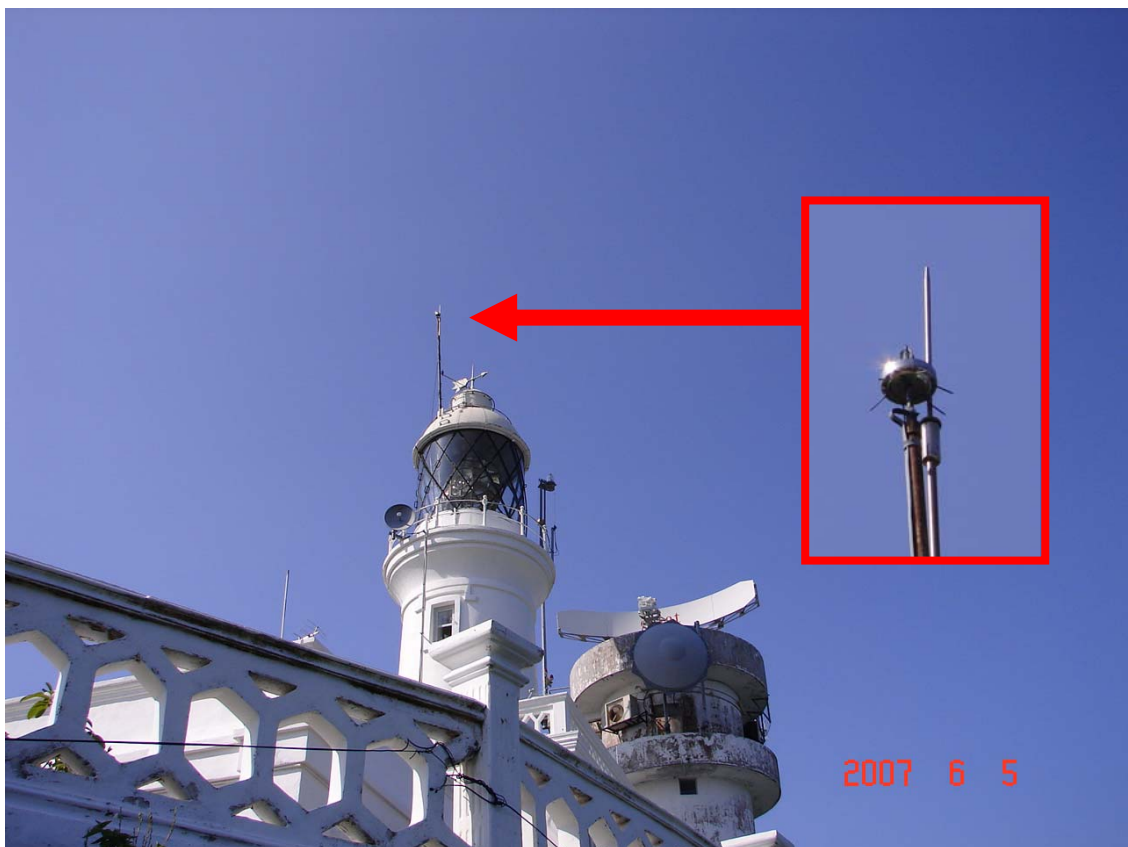
Fig. 15: A Prevector lightning rod (left) and a Pulsar lightning rod (right) at the Cape Rachado lighthouse, Malaysia. Both lightning rods are made to NFC 17-102 standard.

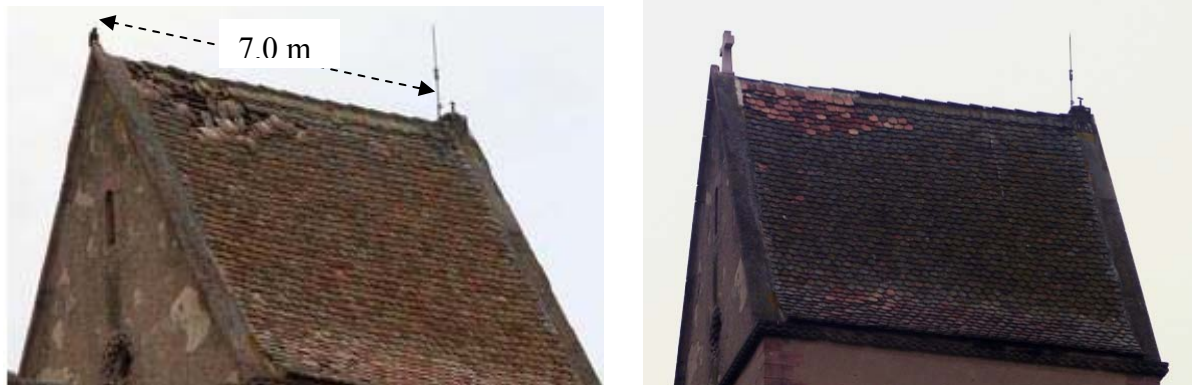
The failures of the ESE lightning rods have been reported not only in high thunderstorm activity areas like Malaysia and Florida but also in France where the thunderstorm activity is very much lower. In the scenic town of Sigolsheim, a stone cross which is located barely seven meters away from a Pulsar ESE lightning rod was struck and damaged by lightning (Fig. 16).

Fig. 16: The bell tower with the (missing) damaged stone cross (left) and the new stone cross installed a year later (right). The ESE lightning rod is installed on the opposite side of the roof.

Since the ESE lightning rod system had been inspected and confirmed to be in working order by independent French technical experts, this suggests that the French ESE standard and the claimed ESE protection zone must be technically unsound. (Reference: Z. A. Hartono and I. Robiah, “The Bell Tower Incident at Sigolsheim”, 2010)
