# **ADVENTURE ISLAND**

# **LIGHTNING INCIDENT**

**AN IN-DEPTH REPORT ON THE DEADLY FAILURE OF AN  
EARLY STREAMER EMISSION LIGHTNING ROD**

**By**  
**Z. A. Hartono & I Robiah**  
**June 2012**  
**E-mail: [zahartono@iecc.org](mailto:zahartono@iecc.org)**

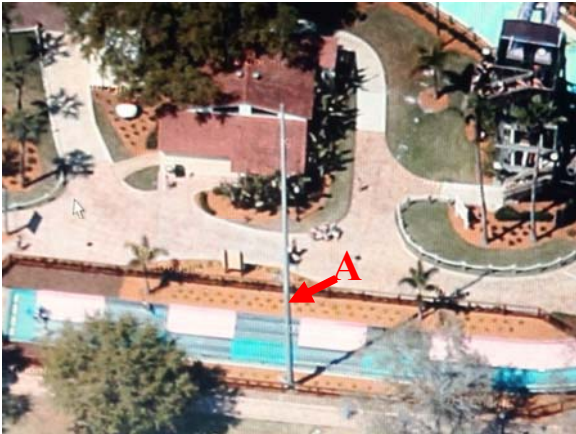
The water slide was found to be located in between two mast-mounted ESE lightning rods, A and B (Fig. 2). The lightning rod A (Fig. 3) is located besides the Riptide pool while the lightning rod B (Fig. 4) is located besides the parking lot access road.

Fig. 3: Location of the ESE lightning rod A (Source: Google map)

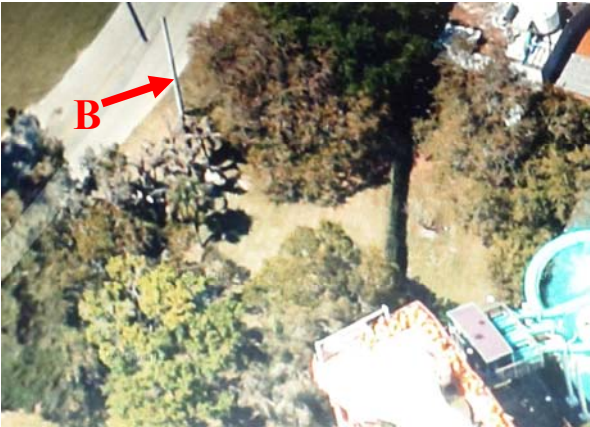
Fig. 4: Location of the ESE lightning rod B (Source: Google map)

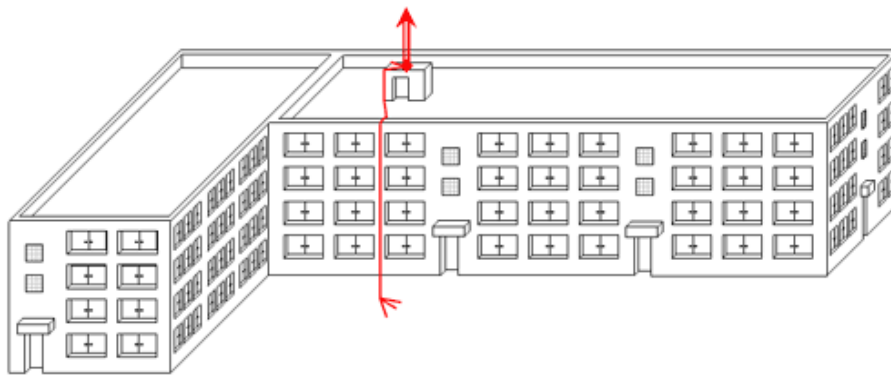
The manufacturers of the ESE lightning rods have claimed that their devices can provide a very large protection zone i.e. up to 100 m or more depending on the make and model of the device. According to GIMELEC, an organisation that is affiliated to the French ESE manufacturers, a single ESE lightning rod installed centrally on the roof can provide protection for the entire building and the open area surrounding the building. This is shown in the GIMELEC diagrams below (figs 9 and 10) for a school building and an adjacent playing field.

Fig. 9: A school building installed with a single ESE lightning rod at the centre of the roof.  
(Source: GIMELEC)

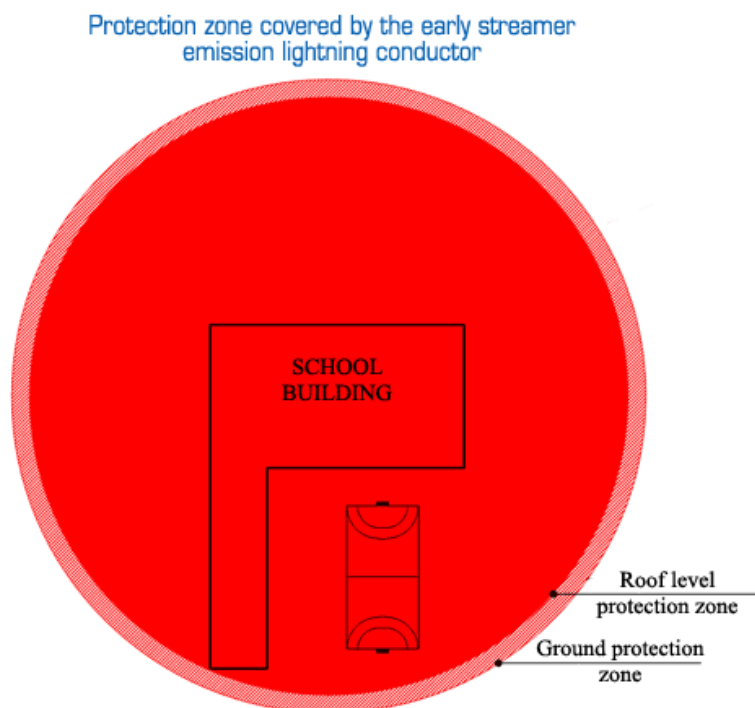
Fig. 10: The claimed protection zone provided by the single ESE lightning rod for the school building and surrounding area (including the playing field). (Source: GIMELEC)

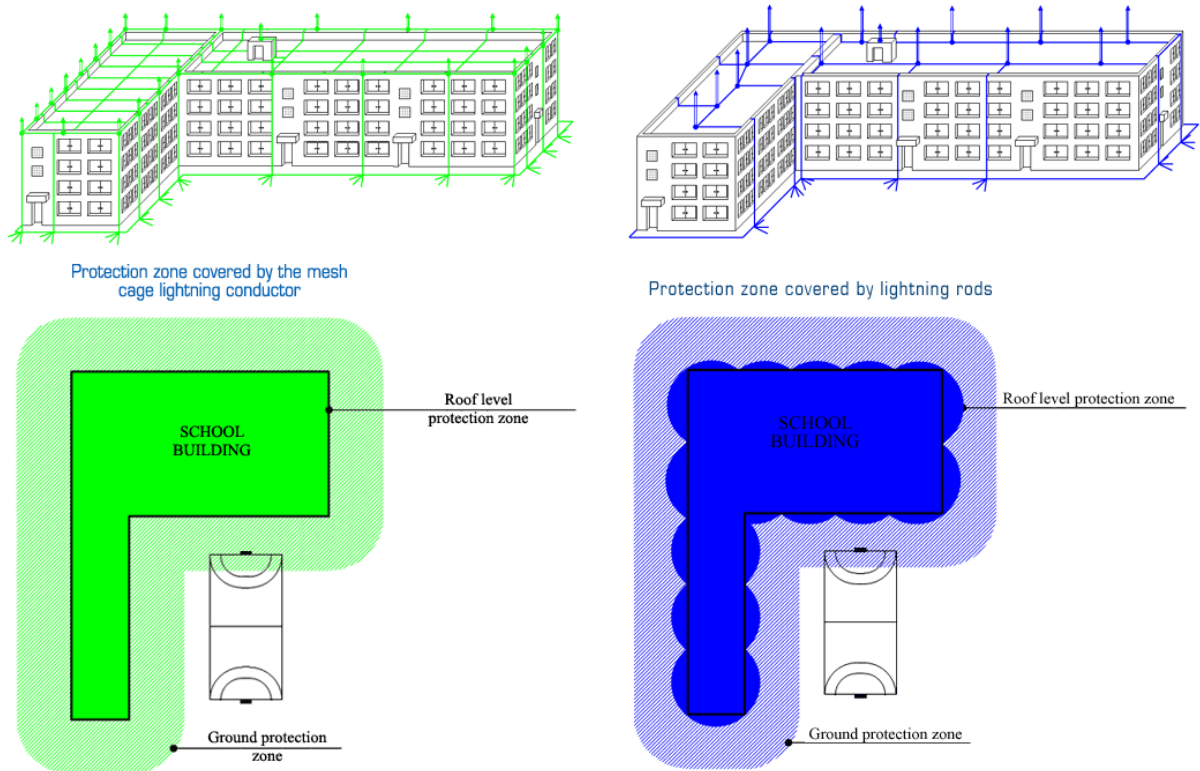
In order to convince the public that the claimed ESE protection zone is bigger than the conventional ones, GIMELEC also posted several diagrams (Fig. 11) to show the smaller protection zones provided by the conventional lightning protection systems. Note that the playing field is only partially included within the conventional protection zones. This suggests that the ESE lightning rod is used to protect open areas and playing fields as well.

Fig. 11: The protection zones provided by the mesh system (above left) and the pole-type lightning rods (above right). (Source: GIMELEC)
